# STAR BRITE

## HOME INSPECTIONS, LLC

PROPERTY INSPECTION REPORT  
PREPARED FOR  
**PETER & MARY ODELL**  
**2613 WINTER DRIVE, PLANO, TX 75023**  
DECEMBER 27, 2010

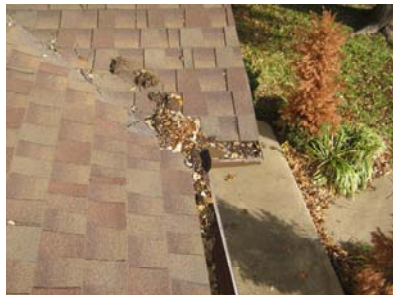
• There were issues where the grading sloped toward the foundation on the left side of the house and to some degree in the front of the house. Excessive water is running down to and ponding in these areas. These issues, if not addressed, will continue to add to the foundation problem. A possible remedy is to install some type of drainage system to divert the excess water to the alley. I recommend that a foundation specialist evaluate further.

• Existing gutter system should be kept clean. This will keep the water moving so that it will not back up into the soffit area where it will form wood decay.

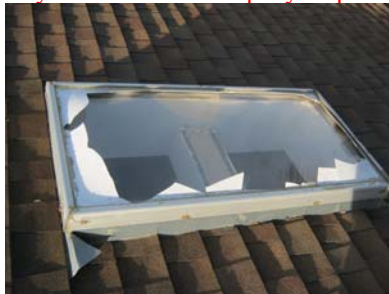
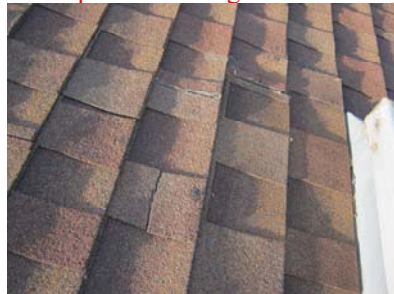
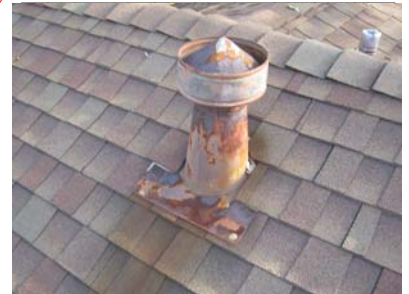
- The roof more or less is at its bottom 1/3 of its useful life. My conclusion is that the roofing material is still in reasonably good condition. There were exposed nail heads which should be patched. The flashing for the chimney was lifted. It should be screwed back down and the screw heads caulked. There was one area where some cracked shingles were poorly caulked. Recommend replacing them.
- The white plastic cover on the skylight was broken. Recommend replacement. The flue for the furnace was badly rusted and was becoming un-nailed. Recommend replacement.
- Roof valleys should be clear of any debris which will form dams which in turn will divert the water in between the shingles.
- Recommend roofing specialist to further evaluate the entire roof and recommend repairs if required. Have your insurance company inspect the roof prior to closing for insurability.

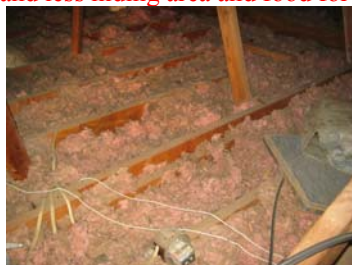
- No obvious significant roof sheathing, structural deficiencies or water stains were found from my limited viewing area of inspection. There were areas of uneven insulation coverage. Recommend smoothing out blown insulation and add extra where needed. I recommend at least another 6-“ of insulation added.
- Indoor pull down attic stairs should be insulated for better energy efficiency. All pull down attic stairs should be used with caution. Attic should be free of excessive storage items. This will keep the area safer and less hiding area and food for vermin.

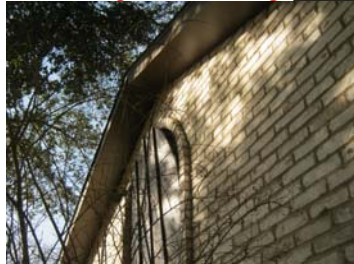
- Overall they were in serviceable condition. Most older windows and their latches will be a little difficult to open and close.
- There were several window screens missing and/or torn. Recommend replacement. The wooden covers above the window were badly deteriorated and coming loose. Recommend repairs.
- I recommend all windows with noted deficiencies to be inspected by a window specialist for a further evaluation prior to closing.

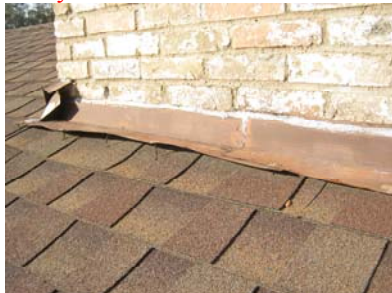
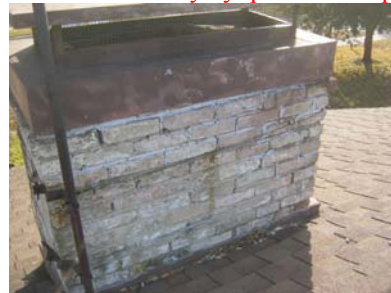
**Fireplace:** The fireplace gas burner and components looked like they were in reasonably good working order. Interior areas of the flue were inaccessible and conditions remain undetermined. Recommend hiring a professional to clean the firebox, evaluate and/or make repairs (if necessary) to the components before usage. I could not inspect the functioning capabilities because the gas was not connected.

**Chimney:** The mortar on the exterior chimney stack looked like it would need replacing or perhaps the entire chimney brickwork will need replacing. I recommend that a chimney specialist make the final decision. I also recommend installing a “saddle” at the base of the chimney on the high side. This miniature pitched roof will help divert rainwater around the chimney.

- Any deficiencies found should be corrected immediately by qualified fireplace technician.

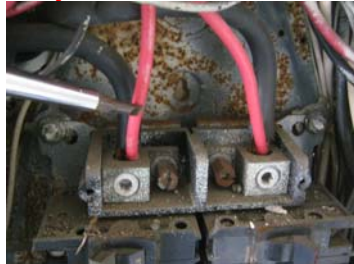
- Main breaker panel box was overall wired in a professional manner. AFCIs were missing. They were not required at the time this house was built. Nevertheless TREC requires us to report this condition as deficient. The box was badly rusted and all the wire connections were badly oxidized. The oxidization does not allow for proper connections which may result in arcing and becoming a possible fire hazard. One reason for the oxidization may be that caustic pool chemicals were stored near the panel box. Two additional wires were inserted into the main service cable lug nuts. These lug nuts were meant to hold only one cable each. Doubling up may lead to arcing and a fire hazard. The neutral and ground wires were also doubled and tripled up. Recommend, with electrician’s advice, an upgrade and repairs to meet today’s building standards to address safety concerns.

- Circuit breakers were not clearly and/or adequately identified in directory. Identify and mark down as soon as possible in case you have to turn off a breaker in an emergency or for repair service.

- The panel box was of the Federal Pacific brand. There is an on-going debate about the breakers not tripping quickly when necessary. Recommend electrician to evaluate further.

- Any deficiencies should be immediately evaluated and corrected if necessary by a qualified electrician.

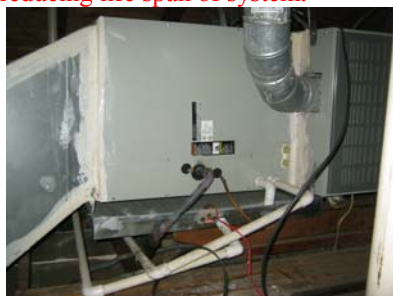
- ✳️ The cooling equipment was not inspected because the electricity was not connected.
- ✳️ The thermostat was outdated. Recommend having a new programmable thermostat installed for better energy efficiency.

- ✳️ The primary condensate drain (white pvc pipe shown below) was missing rubber insulation, a trap and an air vent (manufacturer recommended). The rubber insulation will keep condensation from dripping to the attic floor and eventually thru the ceiling below. The trap will keep sewer gases from back flowing into the air handler which would then distribute them throughout the house. The trap will also keep the cool air from escaping thru the condensate drain vent. Recommend that an HVAC tech to evaluate further.

- ✳️ Recommend licensed HVAC tech to evaluate, recommend repairs (if any), clean coils on both indoor and outdoor units before use for better efficiency and energy savings. Dirty coils reduce air flow thereby reducing life span of system.

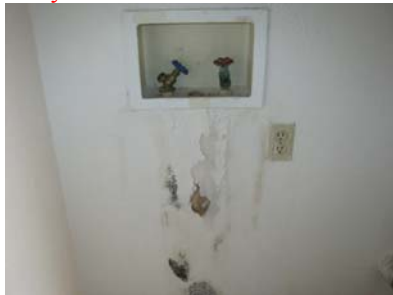
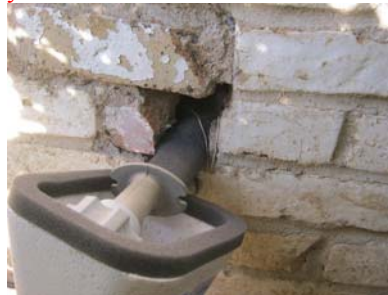
✳️ **Interior:** I could not inspect their function capabilities because the water meter was locked. Water pressure may be slightly different throughout all older fixtures due to the possibility of defective valves and/or clogged plumbing lines. If water supply has been turned off for more than 30 days, faucet drips may appear later when system is in full use.

✳️ The hot and cold water washing machine hose connection area was badly water stained. Recommend a plumber to evaluate further.

✳️ The shut-off valves were difficult to open and close. Replace as soon as possible or monitor for future leaks.

✳️ **Exterior:** I could not inspect their function capabilities because the water meter was locked. Back flow preventers were missing. Recommend installing them to keep dirty exterior ground water from re-entering the interior water supply piping. They can be purchased at any hardware store. The void in the bricks thru which the exterior bib enters the house was too large. Recommend caulking.

✳️ Any deficiencies should be immediately evaluated and corrected if necessary by a qualified plumber.

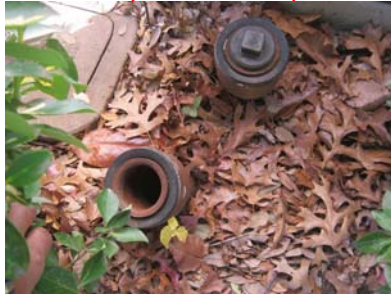
I could not inspect their function capabilities because the water was not connected. The cover to one of the clean out traps should be replaced. Debris or vermin may clog your main drain.
